Manhole Inspection Summary

Manhole # S41E__003MH

Location Address: **1228 E BALTIMORE ST**

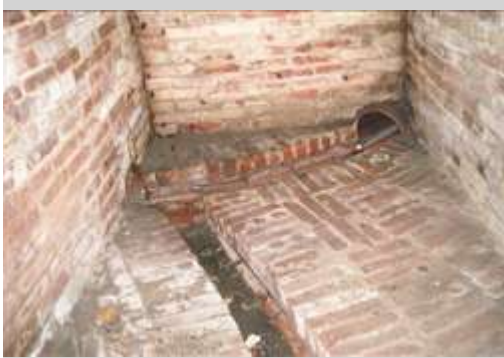
Miscellaneous

DEBRIS IN CHANNEL

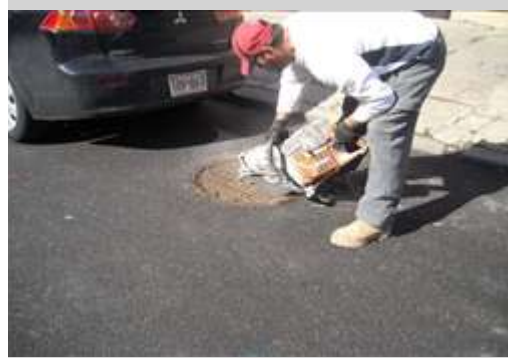
Misc

USED SAW TO BREAK OPEN LID

Comments **OBSERVED THAT MANHOLE LID WAS CRACKED AND SEALED WITHIN FRAME. USED 16LB MAUL TO BREAK THROUGH, AND A SAW TO BREAK SEAL. REMOVED AND REPLACED WITH NEW 24" SANITARY LID. INSPECTION COMPLETED USING MAN ENTRY TO OBTAIN ALL PICTURES.**

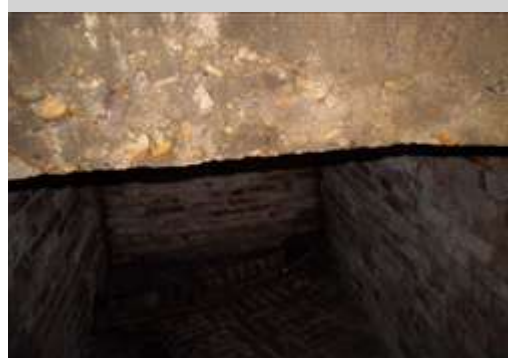
Misc

CONCRETE SLAB OVER BARREL

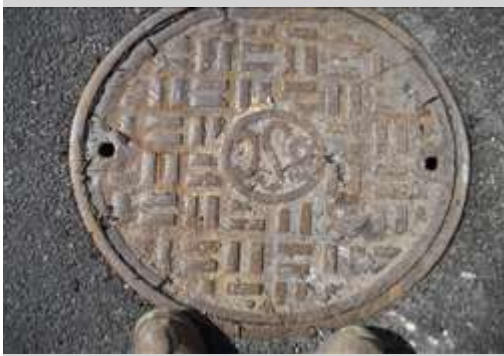
Misc

BROKEN PREVIOUS
MANHOLE-ARRIVED ON SITE TO FIND
LID WELL CRACKED - THIS PICTURE

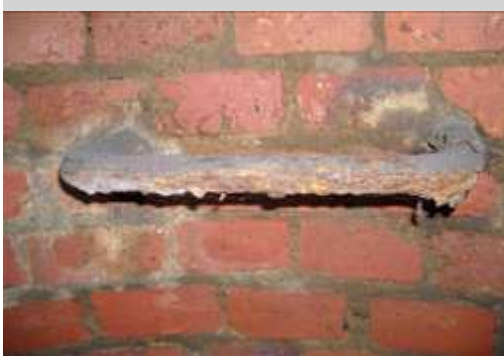
Defect 6

Steps Count: **7** Missing: **0** ☒ **Corroded**

SEVERELY CORRODED STEP

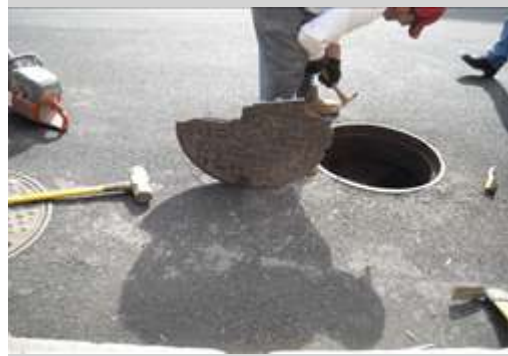
Misc

BROKEN LID

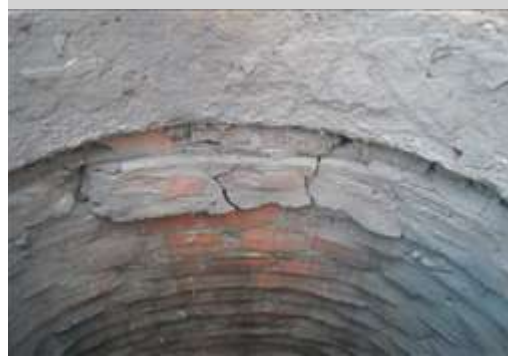
Defect 7

Condition: ☐ Sound ☒ **Cracked** ☐ Root Intrusion ☐ Loose Brick ☒ **Deteriorated**

CRACKED AND BROKEN CHIMNEY
ADJUSTMENT OF 5"

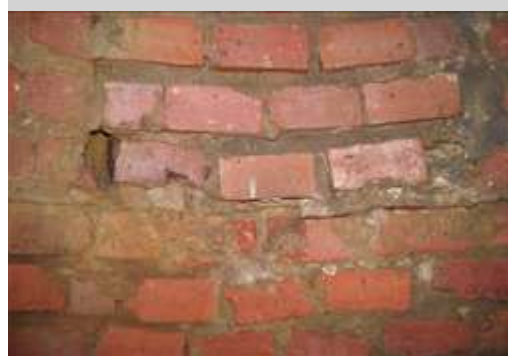
Defect 5

Condition: ☐ Sound ☐ Cracked ☐ Root Intrusion ☐ Loose Brick ☒ **Deteriorated**

Condition: ☐ Sound ☒ **Cracked** ☐ Root Intrusion ☐ Loose Brick ☒ **Deteriorated**

CRACKS AND MISSING MORTAR AT
CORBEL/BARREL JOINT

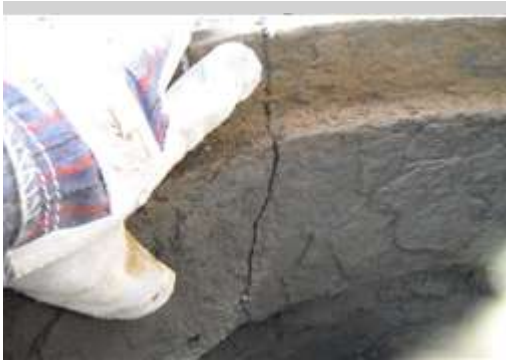
Defect 2

Frame Offset: **0** (in.) Condition: ☐ Sound ☒ **Cracked** ☐ Leaks

LARGE CRACK IN FRAME

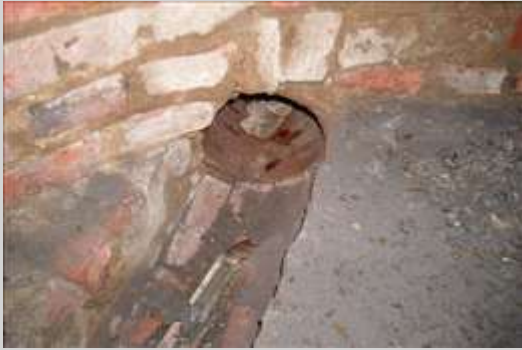
8 O'Clock Inflow

Deposits: ☐ None ☐ Mud ☐ Sludge ☒ **Debris** ☐ Grease

Silt Depth: **1** (in.) Deposits Extent: **Light**
